Manhole Inspection Summary

Manhole # S35Y1_008MH

Insp Date: **11/20/07 1:47 PM**

Location Address: **3802 Leadenhall St.**

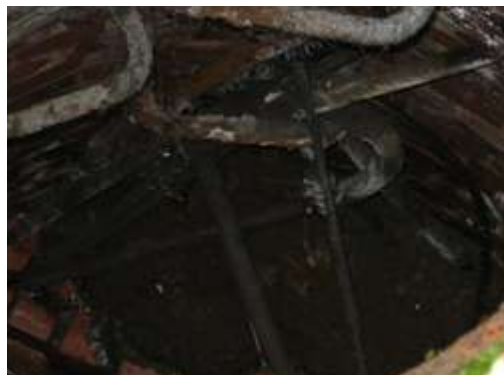
Defect 2

Large object/amount of dirt on bench

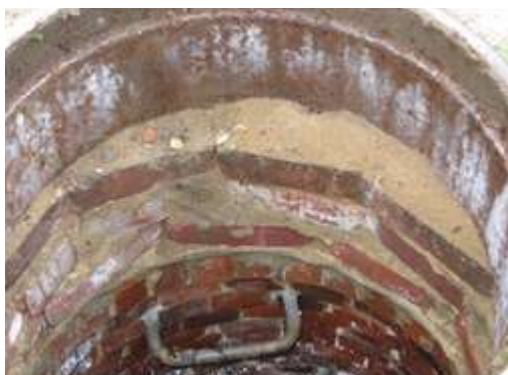
Defect 1

Offset: **4** (in.)

Frame offset

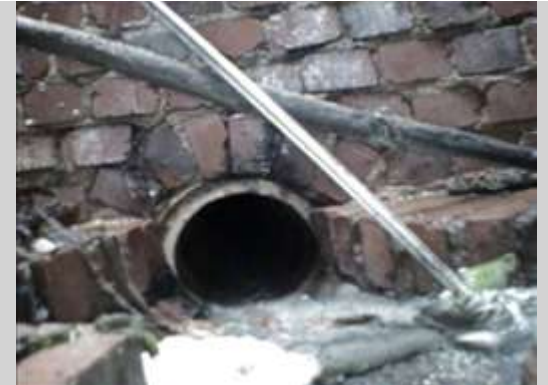
12 O'Clock Outflow

8 in. Circular Gravity Sewer
Pipe Out @ 12 O'Clock

Pipe Height: **8.4** (in.) Rod and Bar (Angled)
Pipe Material: **Clay** ☐ Pipe Lined
Invert Depth: **8.80** (ft.) Flow Characteristics: **Fast**
Deposits: ☒ None ☐ Mud ☐ Sludge ☐ Debris ☐ Grease
Silt Depth: (in.) Deposits Extent:
Infiltration: **None** Pipe Seal Cond: **Sound**

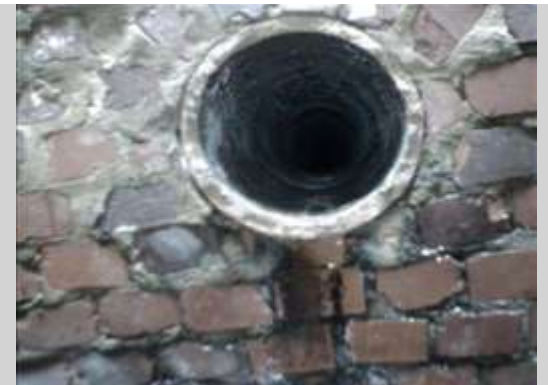
3 O'Clock Inflow

10 in. Circular Gravity Sewer
Pipe In @ 3 O'Clock

Pipe Height: **8.4** (in.) Rod and Bar (Angled)
Pipe Material: **Clay** ☐ Pipe Lined
Invert Depth: **6.98** (ft.) Flow Characteristics: **None**
Deposits: ☒ None ☐ Mud ☐ Sludge ☐ Debris ☐ Grease
Silt Depth: (in.) Deposits Extent:
Infiltration: **None** Pipe Seal Cond: **Sound**

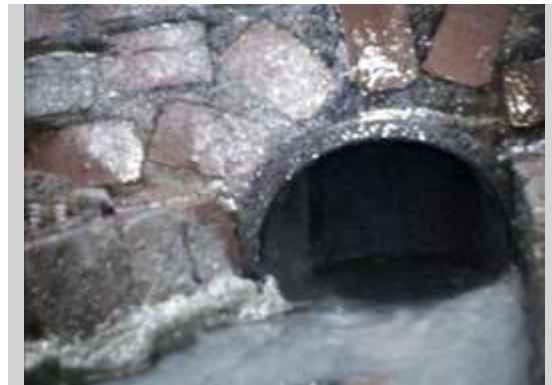
Pipe In @ 3 O'Clock

Drop: **Outside** Rod and Bar
Angled: **Yes** Reading: **8.86** (ft.)
Inv Depth: **9.86** (ft.)
Drop Condition: **Open**

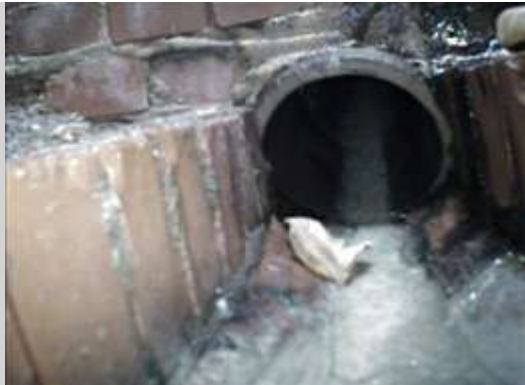
6 O'Clock Inflow

6 in. Circular Service Sewer
Pipe In @ 6 O'Clock

Pipe Height: **7.2** (in.) Rod and Bar (Angled)
Pipe Material: **Clay** ☐ Pipe Lined
Invert Depth: **8.47** (ft.) Flow Characteristics: **Fast**
Deposits: ☒ None ☐ Mud ☐ Sludge ☐ Debris ☐ Grease
Silt Depth: (in.) Deposits Extent:
Infiltration: **None** Pipe Seal Cond: **Sound**

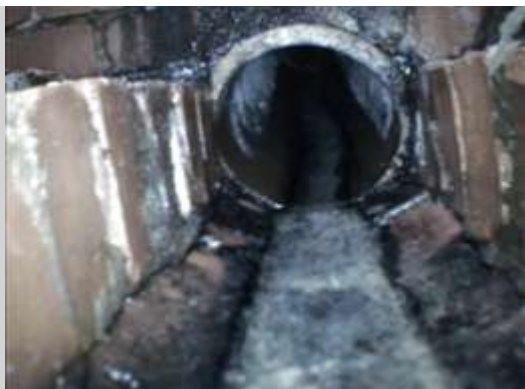
8 O'Clock Inflow

6 in. Circular Service Sewer
Pipe In @ 8 O'Clock

Pipe Height: **6** (in.) Rod and Bar (Angled)
Pipe Material: **Clay** ☐ Pipe Lined
Invert Depth: **8.32** (ft.) Flow Characteristics: **Fast**
Deposits: ☒ None ☐ Mud ☐ Sludge ☐ Debris ☐ Grease
Silt Depth: (in.) Deposits Extent:
Infiltration: **None** Pipe Seal Cond: **Sound**
